HIGH SCHOOL
352,599 SF

ARCHITECTURAL	PRIORITY LEVEL							DESCRIPTION	CORRECTIVE ACTION	ESTIMATED COST	IMAGES
	P0	P1	P2	P3	P4	MP	NA				
Parking Lot		X						The main parking lot for the football field has two sections at different ages of construction. Both of which should be replaced.	Replace 125,000 sf of parking lot with new base and asphalt.	\$500,000

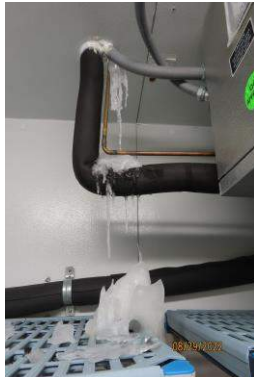
Walk-in Cooler & Frz					X	Existing American Panel units in good physical condition. There are issues with the ceiling panels leaking air and creating ice buildup. Recommend a complete tear down of the panelized systems, investigation as to why there are air leaks and provide corrective measures.	None	\$25,000

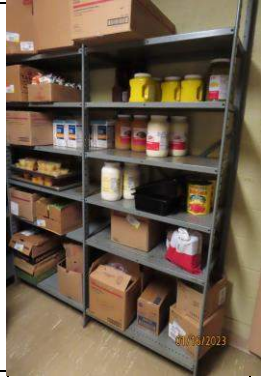
Walk-in Cooler & Frz					X		Existing American Panel unit in good physical condition and operating at correct temperatures	None			
Dry Storage Area						X	Space is adequate. Existing shelving is not code compliant	Replace shelving	\$10,000
